BLACK GORE CREEK SEDIMENT TOTAL MAXIMUM DAILY LOAD

Black Gore Creek TMDL

Location: Black Gore Creek of the Eagle River Watershed
Client: Eagle River Watershed Council
Date: 2004 - 2020

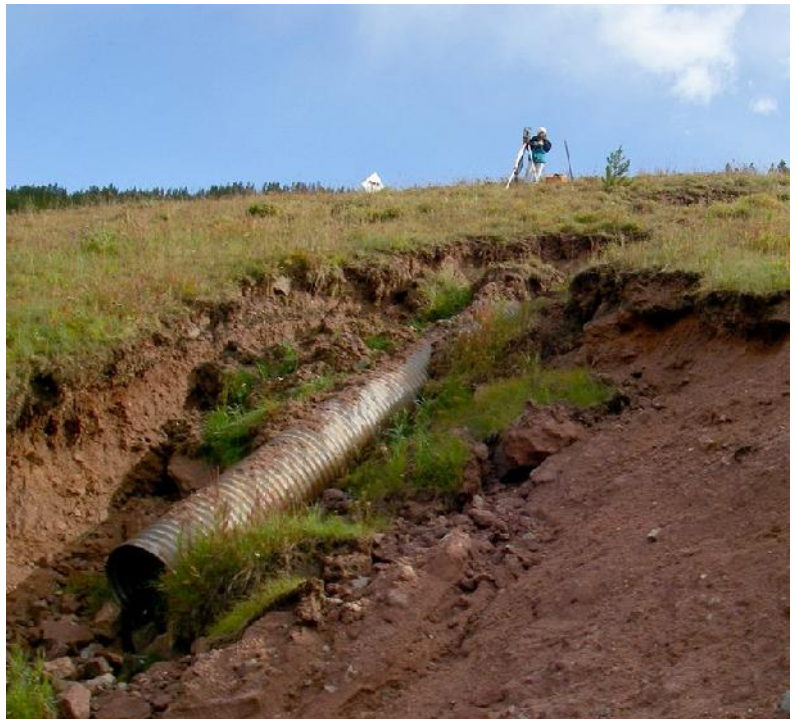
Failing fill slope culvert

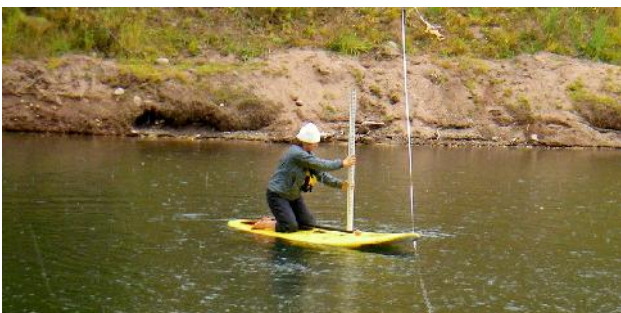
RiverRestoration surveys sediment accumulation along Vail Pass
